36 Henry Street, East Brisbane Qld

DATE OF INSPECTION: Wednesday, 31/08/2006

INSPECTED FOR: Joe Black

REPORT NO: SB2600

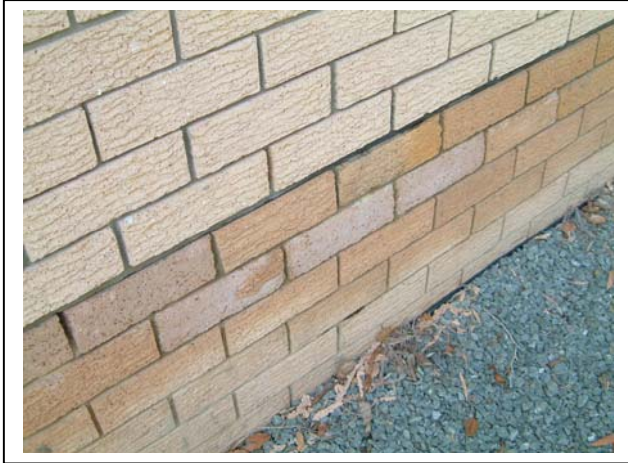
Figure 1:
Fretting to various
bricks along the left side
and back of the
dwelling.

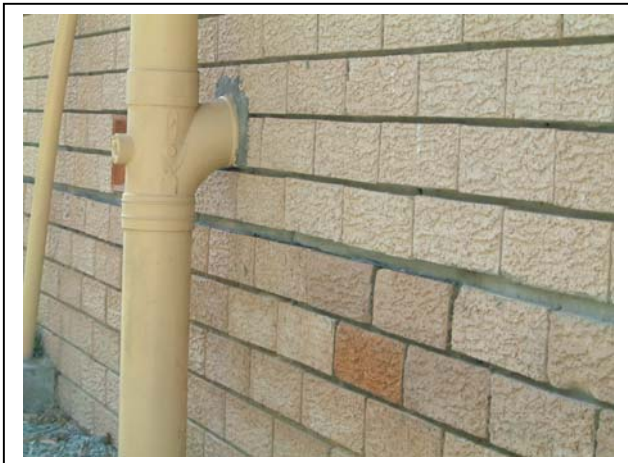
Figure 2:
Evidence of movement/
settlement to the brick
base along the right and
left sides of the dwelling
(the bed joint along the
concrete slab level is
larger than all other joints
and has been patched at
some stage).

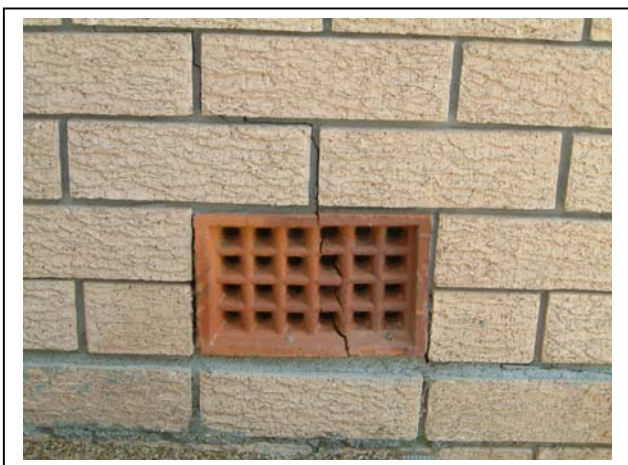
Figure 3:
Cracking to the right
side brick wall (up to
4mm in cracking width).

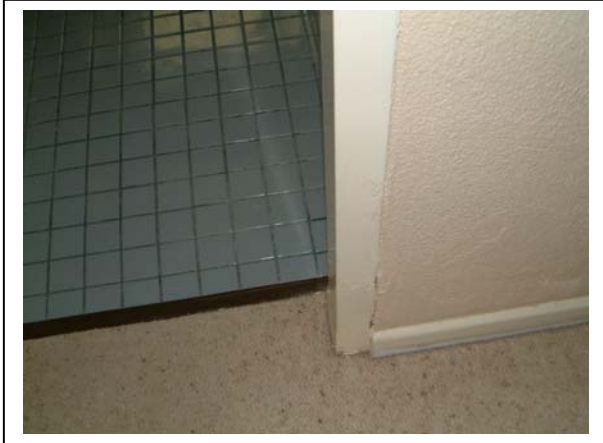
Figure 4:

Evidence of previous leakage to the bathroom metal doorframe (rust and swelling to the metal door frame).

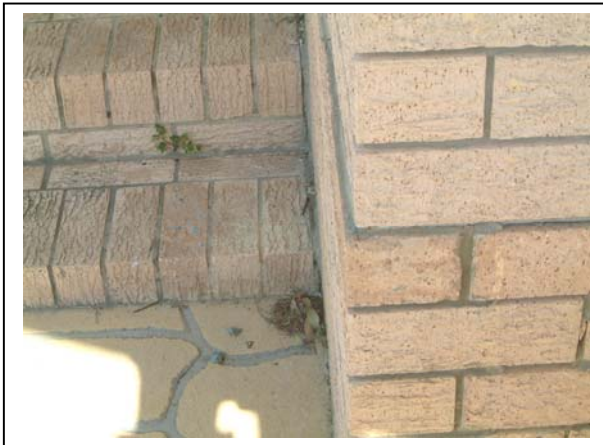
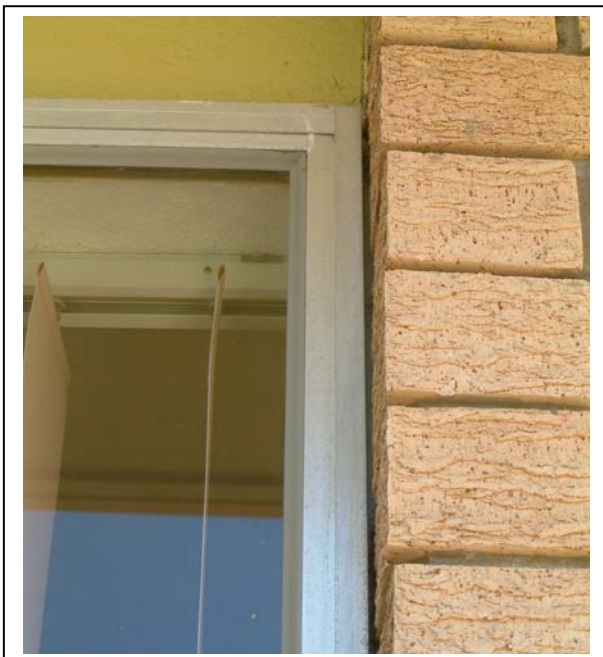
Figure 5 and 6:

Evidence of movement/subsidence to the back right corner brick wall (up to 10mm sideways movement between the brick base and the wall above and up to 5mm gap between the back bedroom window and the brick wall). The movement detected appears do be due to general settlement over time. An Engineer should be consulted if further information on brickwork movement is required.
